GERB Operations Report

GIST 34 - Toulouse - 8th Oct 2014

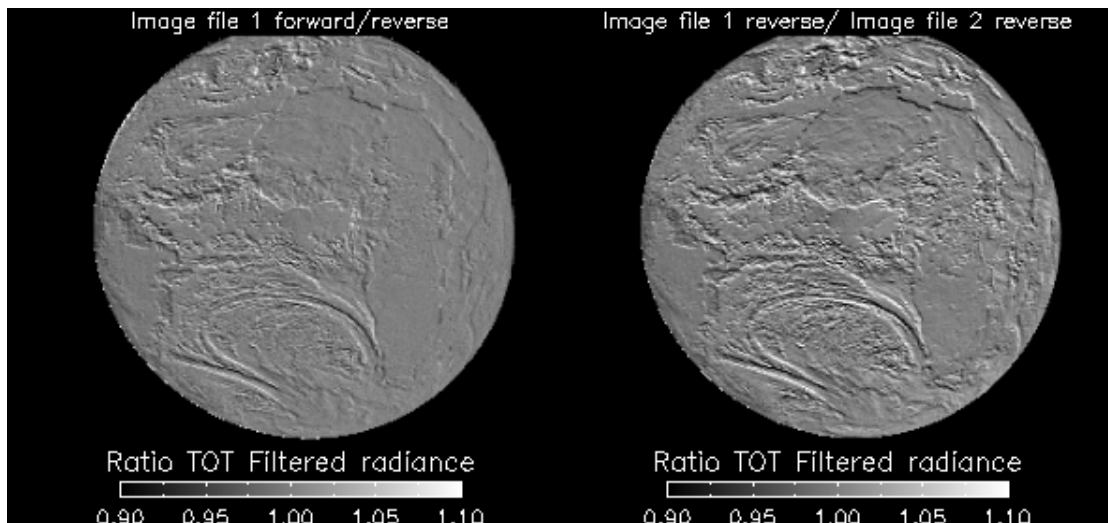
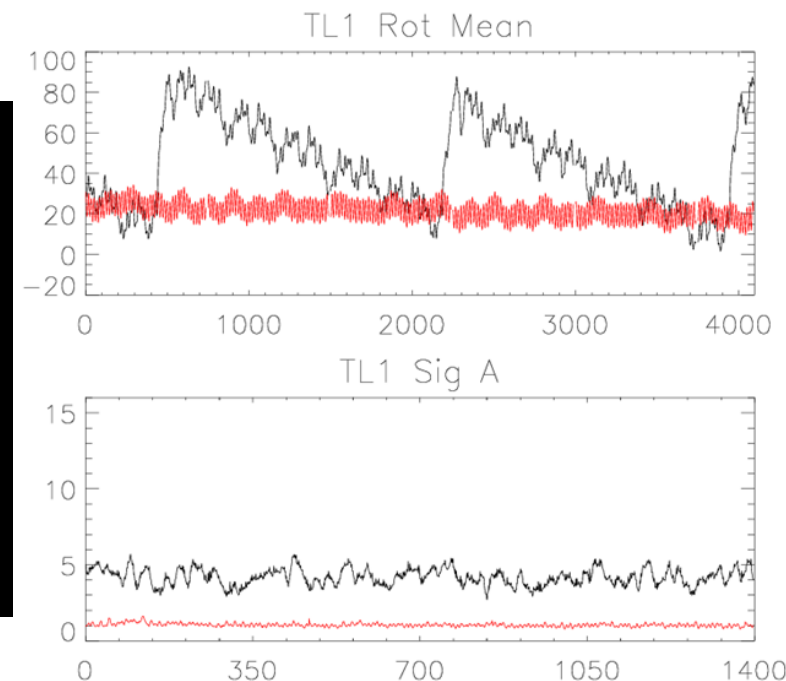
The early operations showed a significant improvement to the pointing accuracy of the despin mirror based on the new drive hardware running three nested control loops, position, velocity and torque.

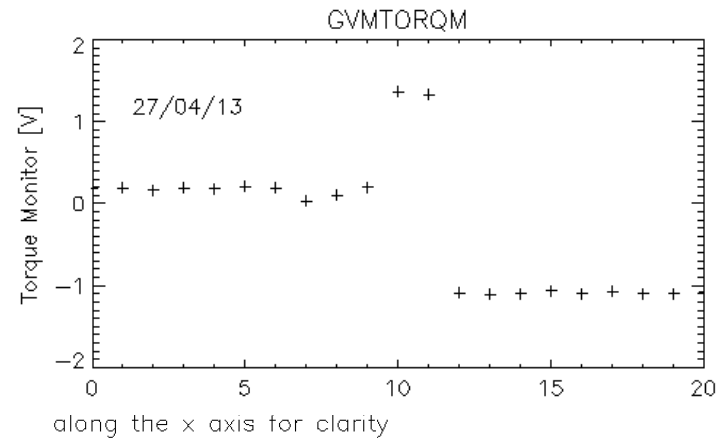
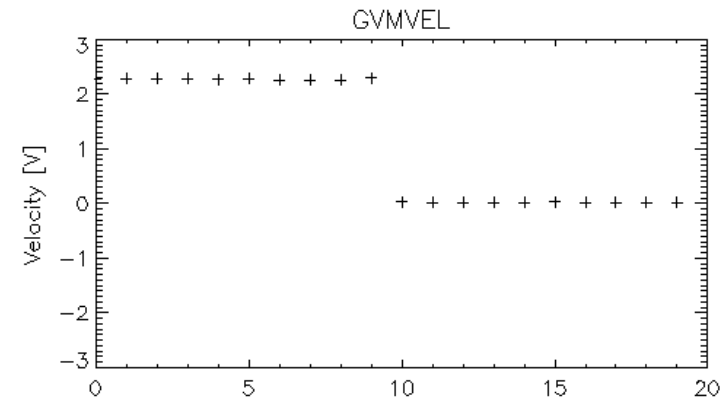
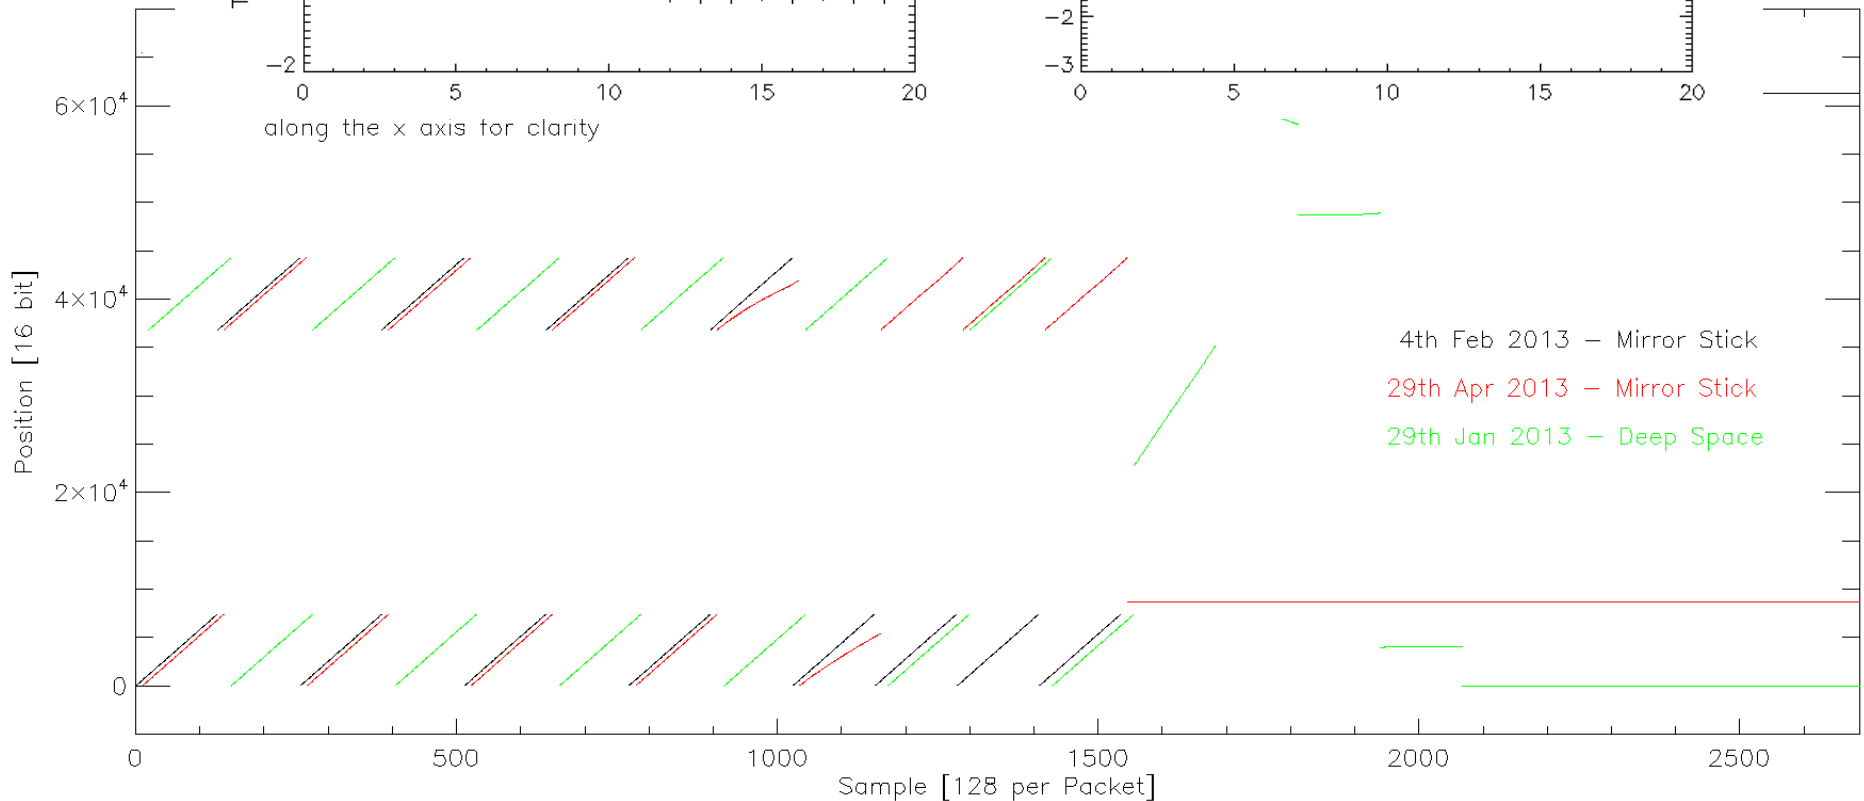
Comparison of Mirror FIFO data

128 mirror position values are given by the FIFO for every rotation for the Earthview regions. The mirror is driven successfully to position zero in the case of the Deep Space threshold violation but for the mirror sticking events no further movement in the DSM is recorded in either case. In case of mirror anomaly FIFO data is repeated (last two red and three black packets before SAFE) as no new valid mirror data is supplied.

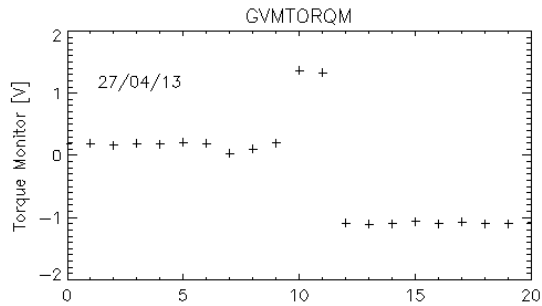
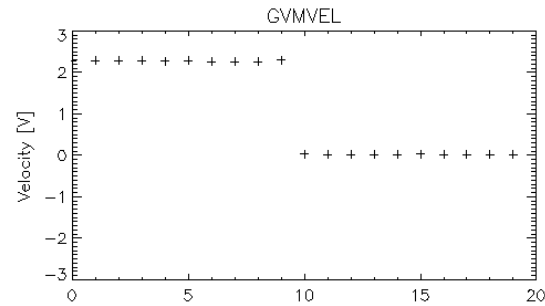
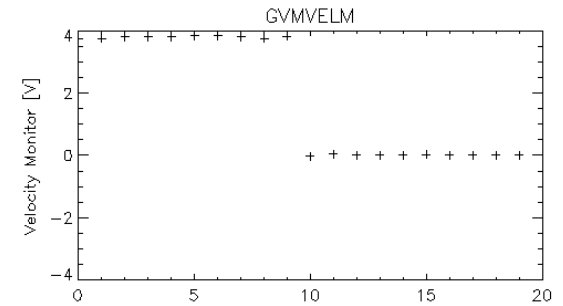
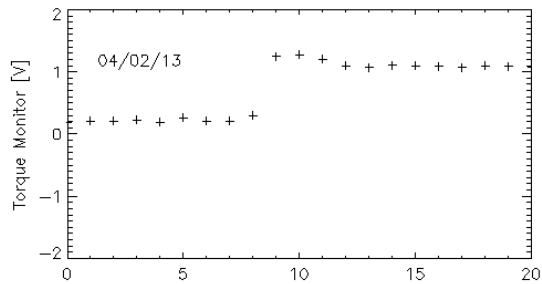
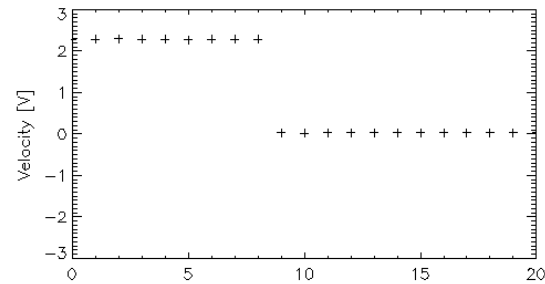
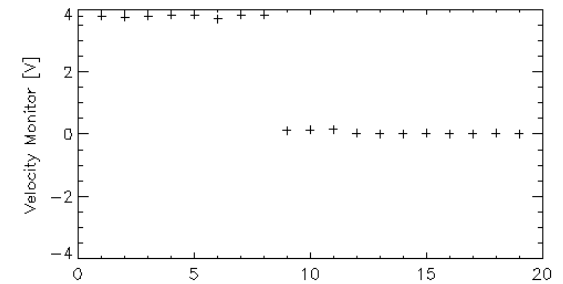
AutoSAFE Incidents Compared

GERB-3 has experienced three more AutoSAFE incidents since launch caused by high signal tripping the deep space column checks.

In these cases no current limits are violated in SAFE mode after the event.

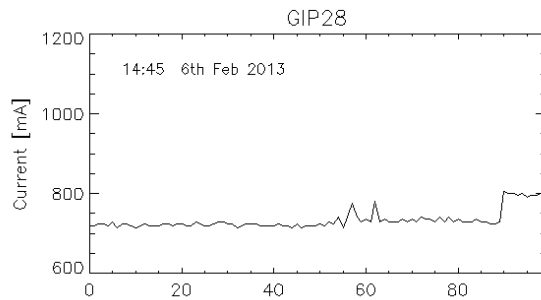
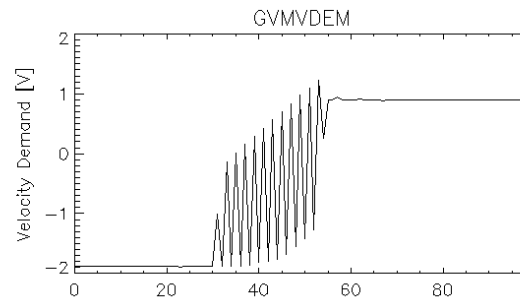
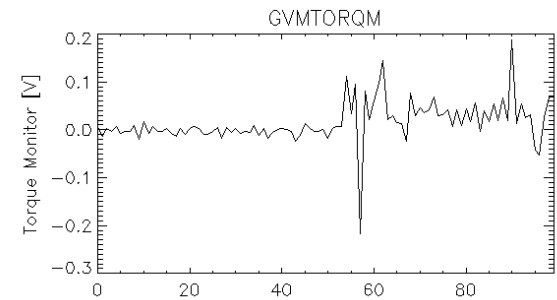
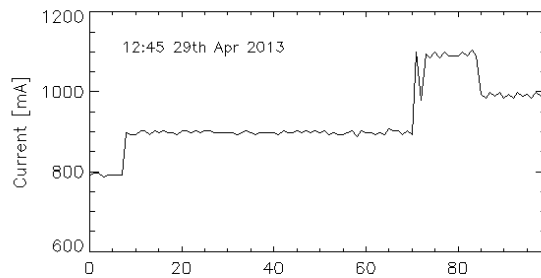
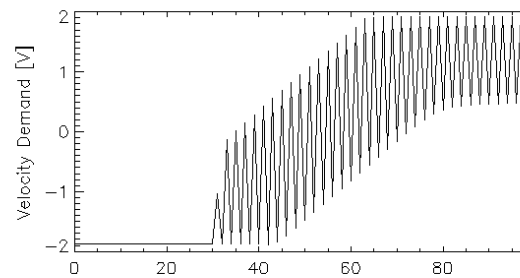
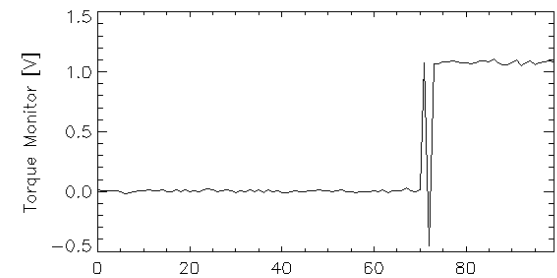
Initial Restart Attempts – Command to SUNBLOCK

Subsequent commanding to NORMAL
mode failed to achieve mirror lock in
SUNBLOCK on two instances (29th April,
2nd May.) Each time the instrument was
returned to SAFE and the DSM disabled.

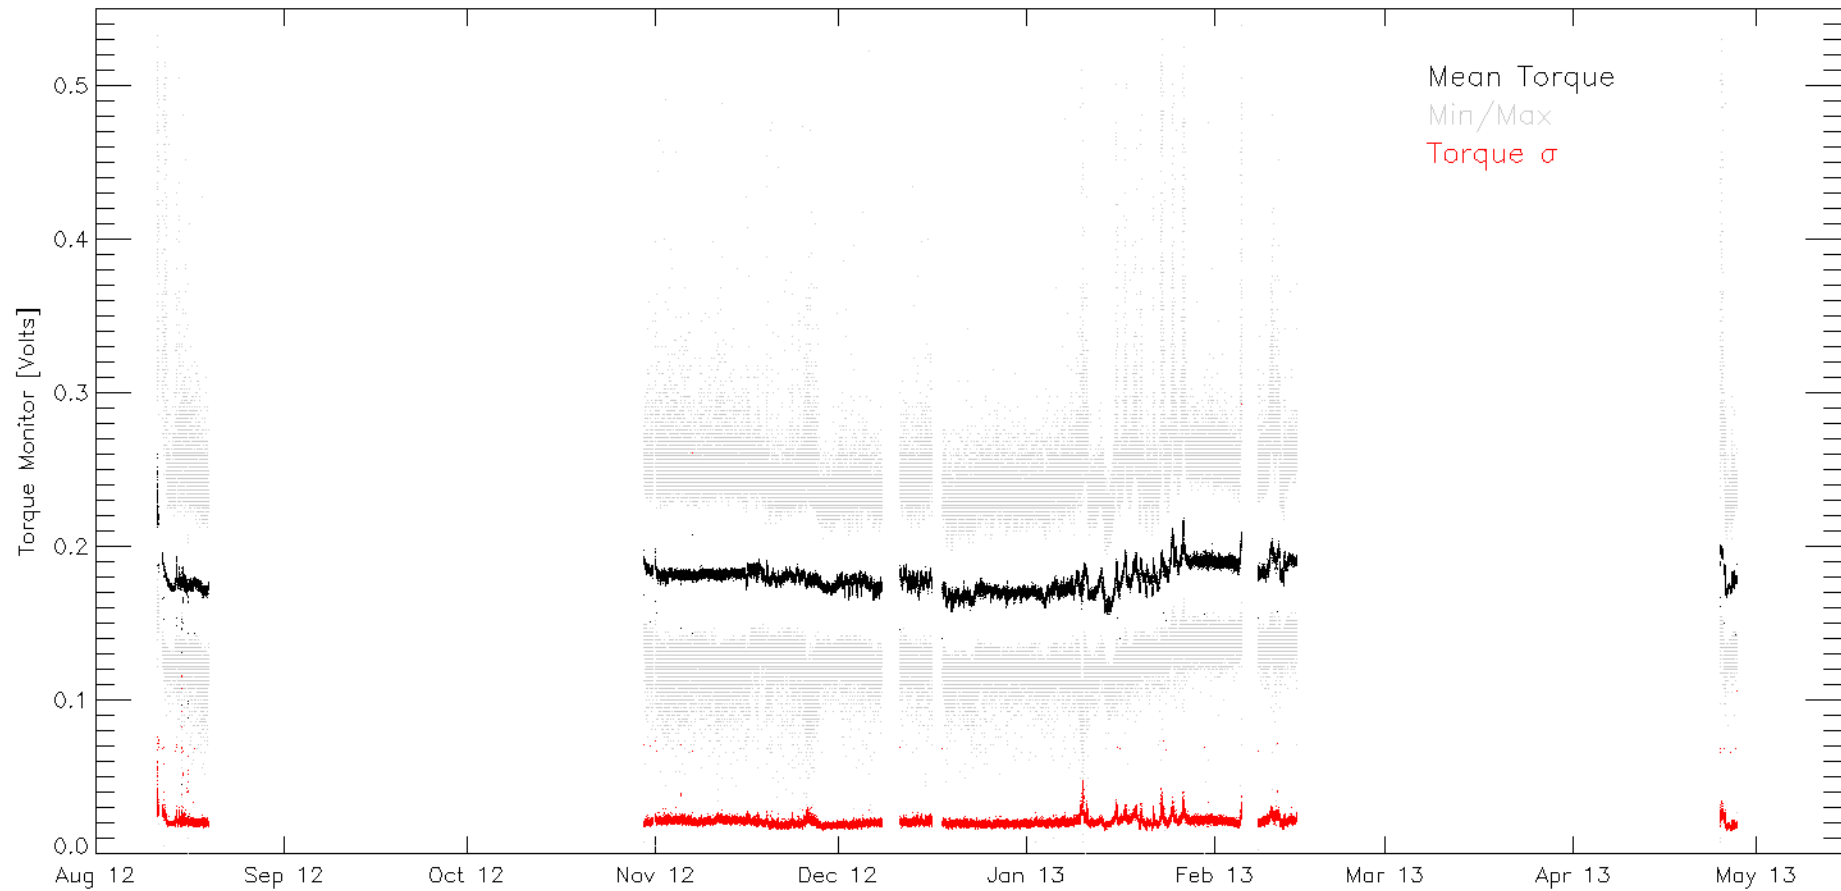
GERB-3 Torque Monitor

In analysis of the two DSM events on GERB-3 it was noted that they were both preceded by AutoSAFE events on the stray light checks.

To ensure no causal connection the torque monitor data was examined in those two incidents and the event from October.

Data is also shown from late in January 2013 when no safety transitions took place.

The proximity appears to be coincidental.

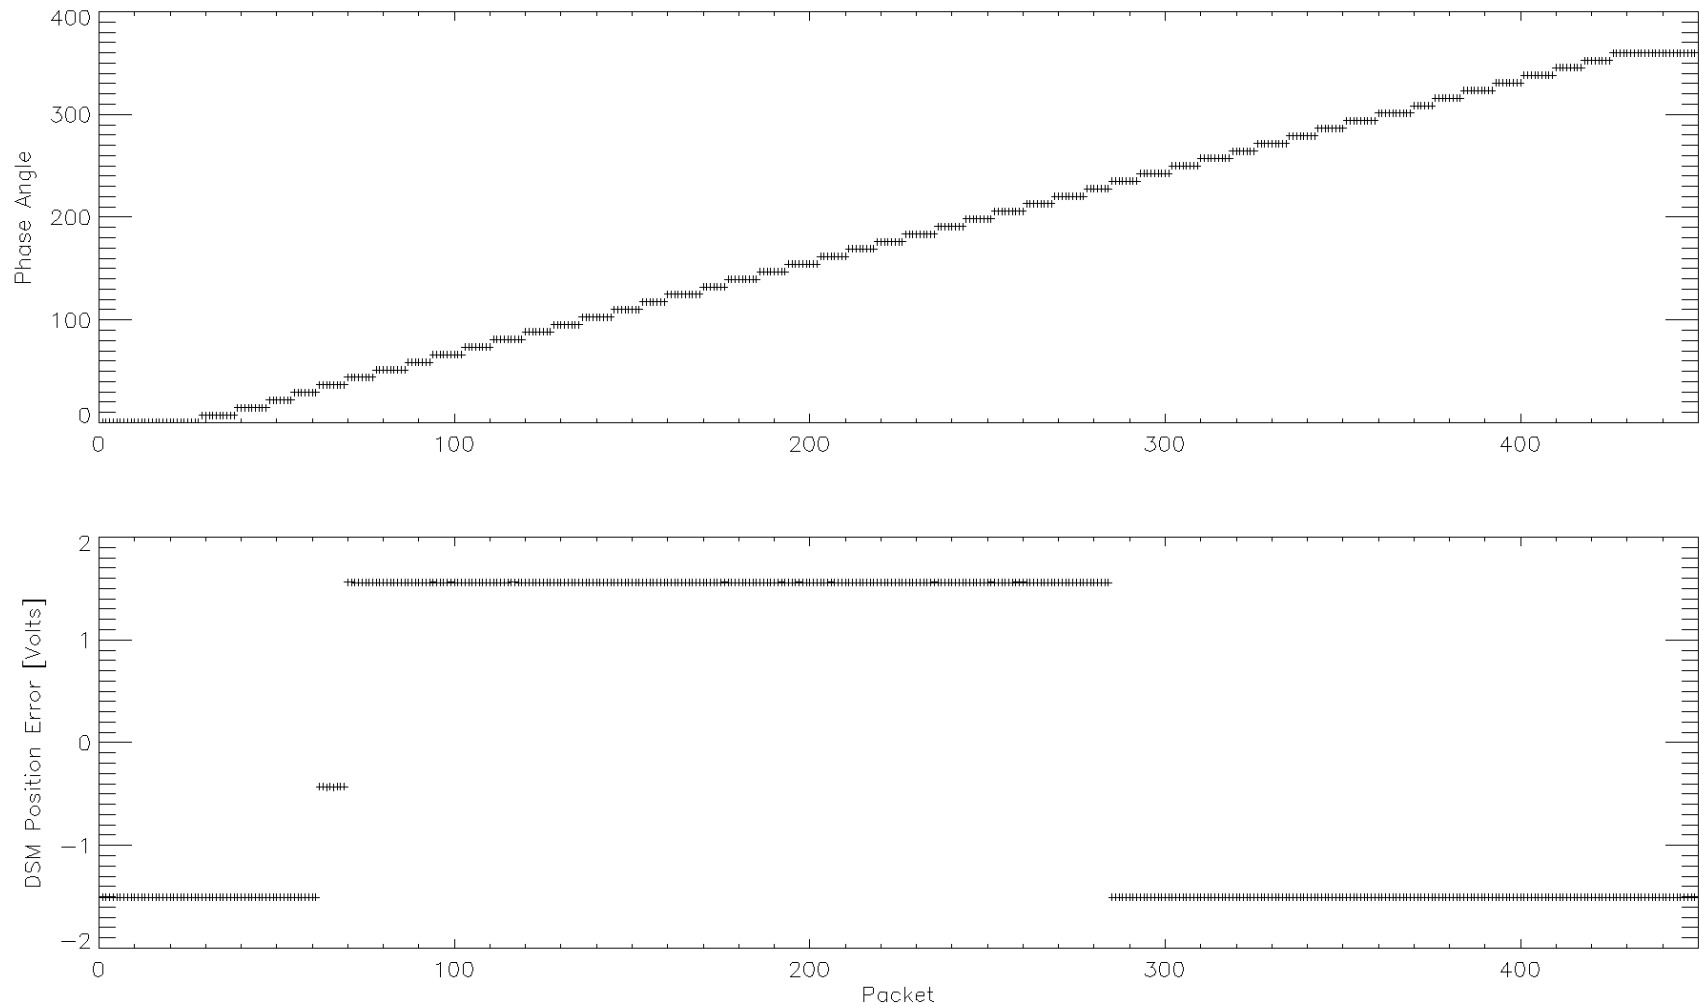
Mirror Phase Sweep through 360°

Date	Test/Operation	Notes	Result	VCS
22 nd May	60° steps backwards from 300°	In SAFE mode, drive enabled	Torque reversal between 240° and 180° (response consistent with assumed mirror position between 0° and 60°) no discernible DMS movement	0x4200 Fine, Track, VE2
23 rd May	+/-90° from 15° FIFO position	In SAFE mode, drive enabled. 40 mins, 10 minutes per command.	Torque reversal but insignificant DMS movement (1 bit flip)	0x4200 Fine, Track, VE2
28 th May	Command to SUNBLOCK	Non standard VC Mode	Small VDEM values, continuous torque reversal (nominal for 0x7200.) No discernable DSM movement.	0x7200 Coarse, Slew, VE2
29 th May	Command to SUNBLOCK	New VC mode	Full scale VDEM value oscillation, continuous torque reversal (nominal for 0x6200.) No discernable DSM movement.	0x6200 Coarse, Track, VE2
5 th June	Full rotation at 7.2° steps	DSM disabled. Test position error response.	Drive system position error shows system apparent position between 36° and 43.2°. Consistent with backward sweep result.	0x1200 Fine, Slew, VE2
